# Metal-deck corrosion: Three case studies

A combination of factors was found to have contributed to major, unpredictable patterns of deck corrosion

by Richard P. Canon, RRC, PE

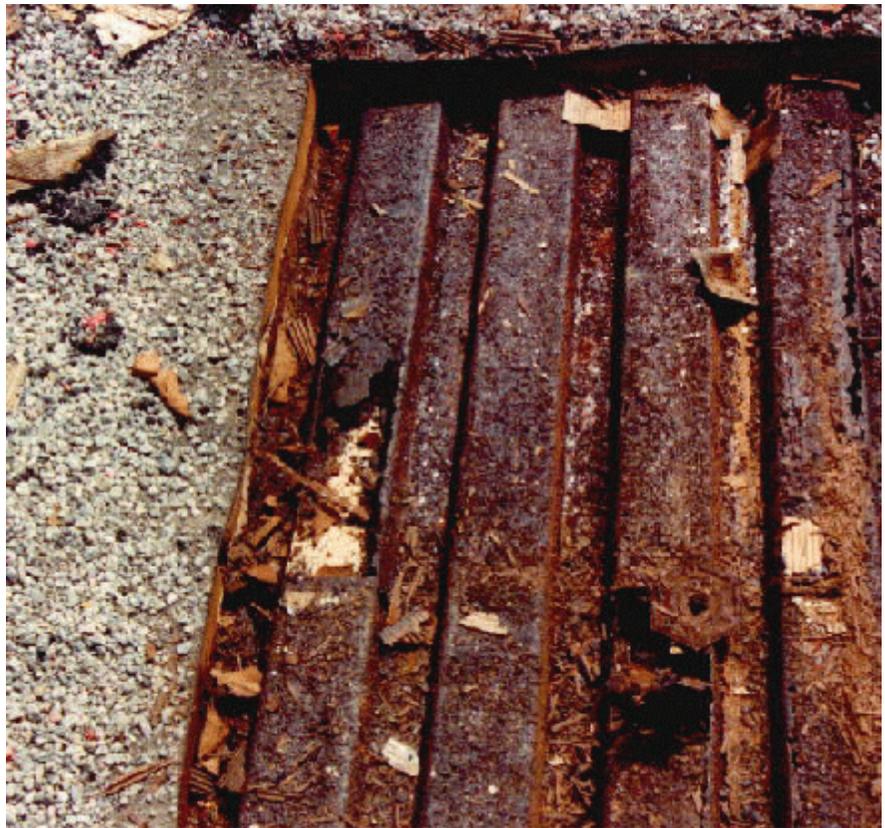
**Figure 2: From Project No. 1, severe corrosion of deck, plate, and fastener.**

the deck. In the most heavily corroded areas, all surfaces were corroded: flange, web, and flute. **Numerous galvanized insulation fastener plates were heavily pitted and corroded.**

The physical condition of the insulation and the extent of corrosion, however, led the author to recommend a total removal of the roof system to the deck. It would then be necessary to replace seriously deteriorated deck and to coat moderately corroded deck with a high-solids epoxy coating system. After this preparation, a new roof system would be installed.

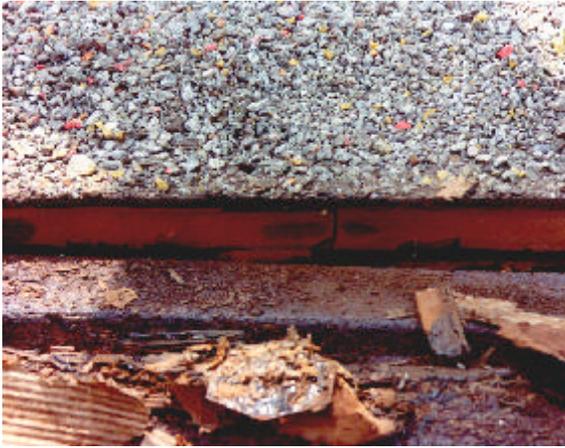
Test cuts and cores confirmed the observations of the IR survey. Areas of phenolic insulation interpreted to be wet were very wet. **Moisture Content By Weight (MCBW)** was measured up to 1,025 percent. Most wet material was found to contain about 250 percent MCBW. Compare these values with the equilibrium moisture content for phe-

**Figure 5:** Project 1, view of wet insulation.

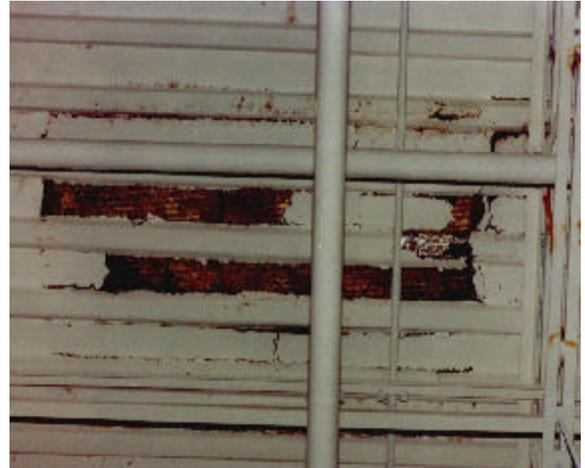
**Figure 6:** Project 1 interior view of corrosion
