# Metal-deck corrosion: Three case studies

A combination of factors was found to have contributed to major, unpredictable patterns of deck corrosion

by Richard P. Canon, RRC, PE

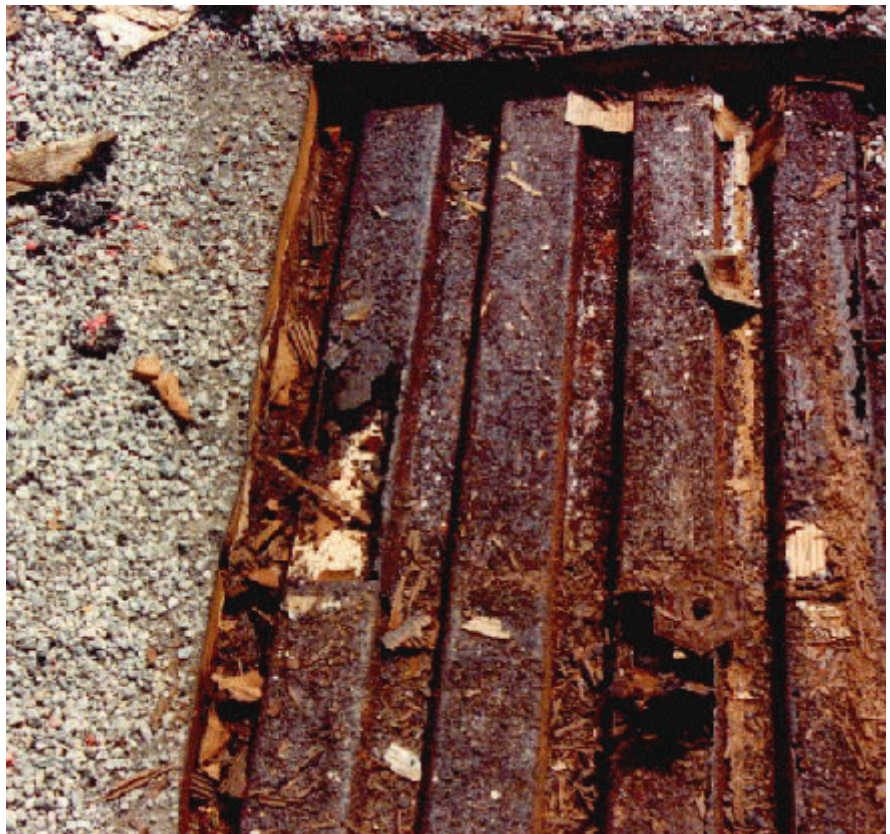
**Figure 2: From Project No. 1, severe corrosion of deck, plate, and fastener.**

the deck. In the most heavily corroded areas, all surfaces were corroded: flange, web, and flute. **Numerous galvanized insulation fastener plates were heavily pitted and corroded.**

The physical condition of the insulation and the extent of corrosion, however, led the author to recommend a total removal of the roof system to the deck. It would then be necessary to replace seriously deteriorated deck and to coat moderately corroded deck with a high-solids epoxy coating system. After this preparation, a new roof system would be installed.

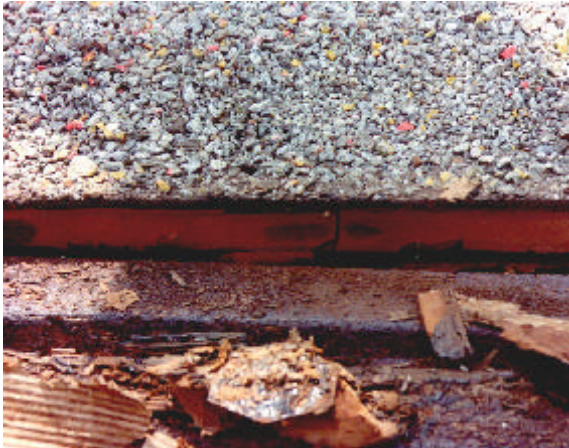
**Figure 5:** Project 1, view of wet insulation.

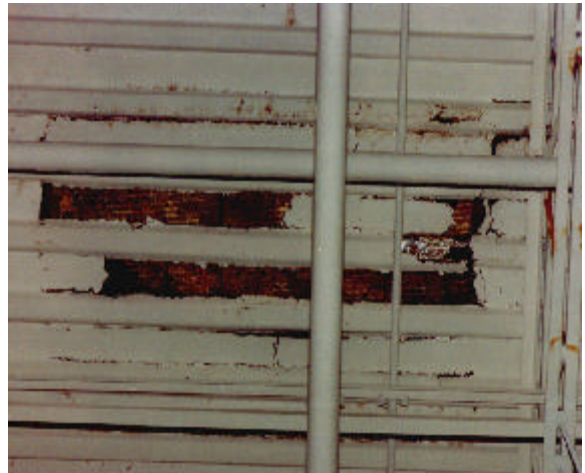
**Figure 6:** Project 1 interior view of corrosion
