# Metal-deck corrosion: Three case studies

A combination of factors was found to have contributed to major, unpredictable patterns of deck corrosion

by Richard P. Canon, RRC, PE

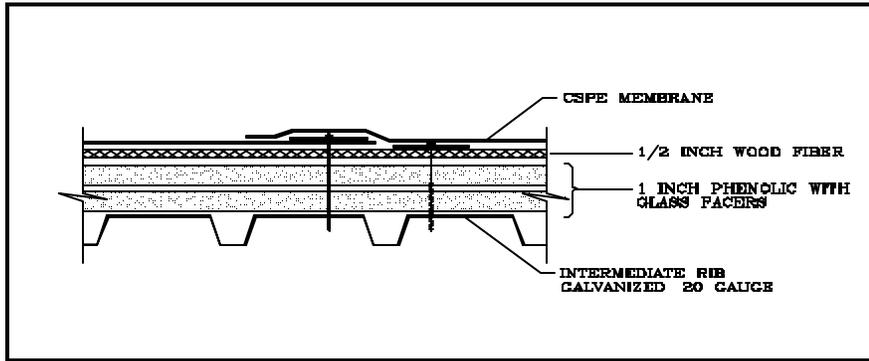
**Figure 4: Project No. 3 Roof Cross Section**

the top flange and was attacking the base metal. No full-penetration rust was observed. \*[THE CORROSION OF THE GALVANIZED COATED DECKING WAS PREDICTED FROM RESEARCH GATHERED ON PROJECT NO. 1, BUT NOW IT WAS CONFIRMED.]\* Although the corrosion was not as severe as on Project 2 (both were the same vintage foam) there was a basis for serious concern.

\*[ANOTHER INTERESTING OBSERVATION WAS MADE WHERE A DECK WELD HAD BEEN PAINTED. THIS PROTECTED THE METAL DECK FROM CORROSION DESPITE ABUTTING CORROSION ON THE BARE DECK. IT APPEARED THAT A GOOD COAT OF PAINT OUT PERFORMED THE GALVANIZE.]\*
